Survey of Rice Lake

Dane County, Wisconsin

Small-scale Lakes Planning Grant Project

November 2011

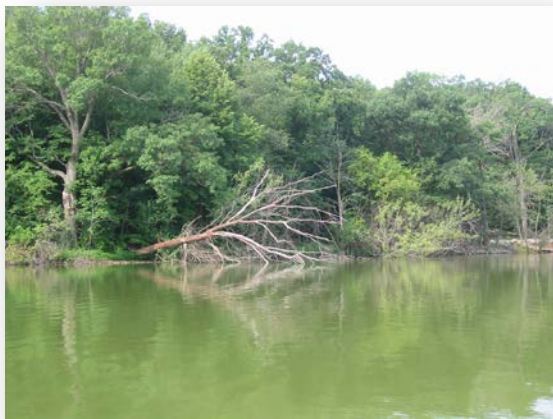
Figure 4: Algal Bloom

Survey results indicated that the lake is hypereutrophic with water clouding Cyanobacteria blooms. See Figure 4. Secchi measurements ranged from 2-3'. Very high pH was measured in the lake and likely reflected photosynthesis of algal blooms with chlorophyll-a concentrations up to 55 ug/l. Even though the lake is shallow and subject to mixing, anoxia was measured just below 1 meter below the surface.

7. Water quality data indicates highly eutrophic conditions. With internal cycling of phosphorus suspected, an analysis of the sediment nutrient conditions should be performed.

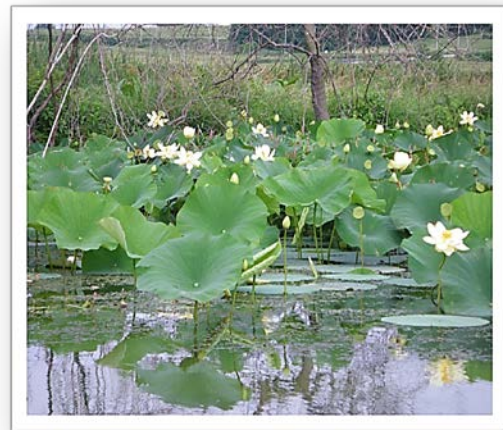
Figure 5: American lotus

Despite the poor water clarity, rooted aquatic plants were observed in modest densities including curly-leaf pondweed, small pondweed, Sago pondweed and Elodea. A substantive American lotus bed was observed in the north bay. See Figure 5.

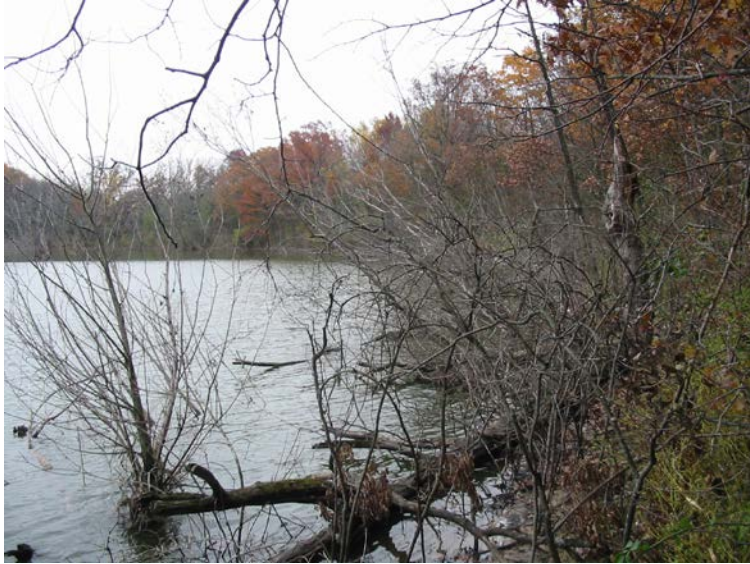
Fish populations were relatively scarce nearshore but may have reflected unusual distribution due to shallow anoxia as mentioned above. Seining and electroshocking revealed modest numbers largemouth bass, crappies, bluegill and immature golden shiners. An angler at the campground reported catching yellow perch, crappies, largemouth bass, bluegill, black bullhead, northern pike and rock bass. She also commented her concern over frequent algal blooms. In 2006, a WDNR boom shocking survey revealed 2 northern pike, 164 bluegill, 6 yellow perch, 14 crappies, 15 black bullhead, 4 golden shiners and 1 green sunfish. No endangered or threatened species were observed but numerous snags around the lake offer favorable turtle basking habitat. See Figure 6.

Figure 6: Favorable woody debris is scattered along the shoreline of Rice Lake. Areas provide critical cover for juvenile fish and habitat for nongame species.
