AMENDMENT 2
**Aquatic Plant Management Plan, Lake Monona and Monona Bay, Lower Rock River Basin,
Dane County Wisconsin**

**Approved by the Dane County Lakes and Watershed Commission on December 21, 2017 and
by the Wisconsin Department of Natural Resources on April 13, 2018**

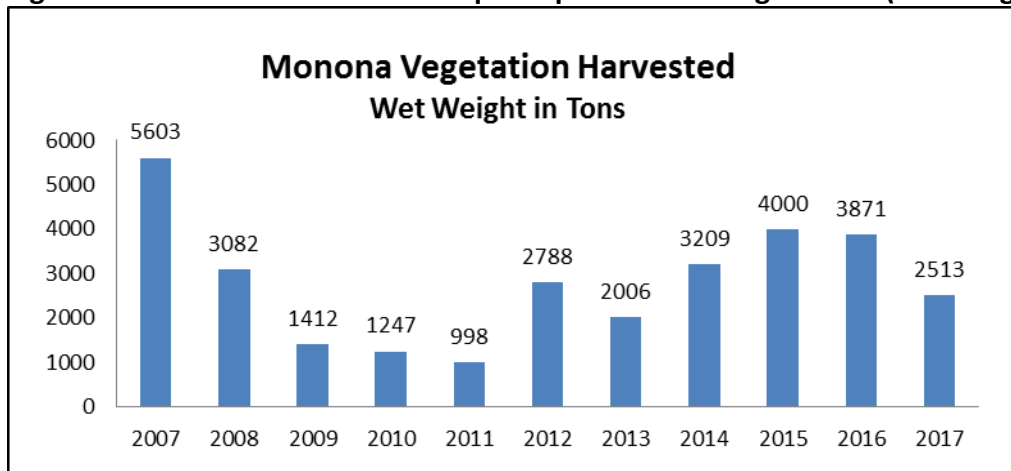
Figure 3. Historical Lake Monona aquatic plant harvesting records (including Monona Bay)

Figure 3 summarizes Dane County’s mechanical harvesting operations in Lake Monona since 2007. According to Wisconsin DNR, the last permit granted for herbicide use on Lake Monona was in 2011.

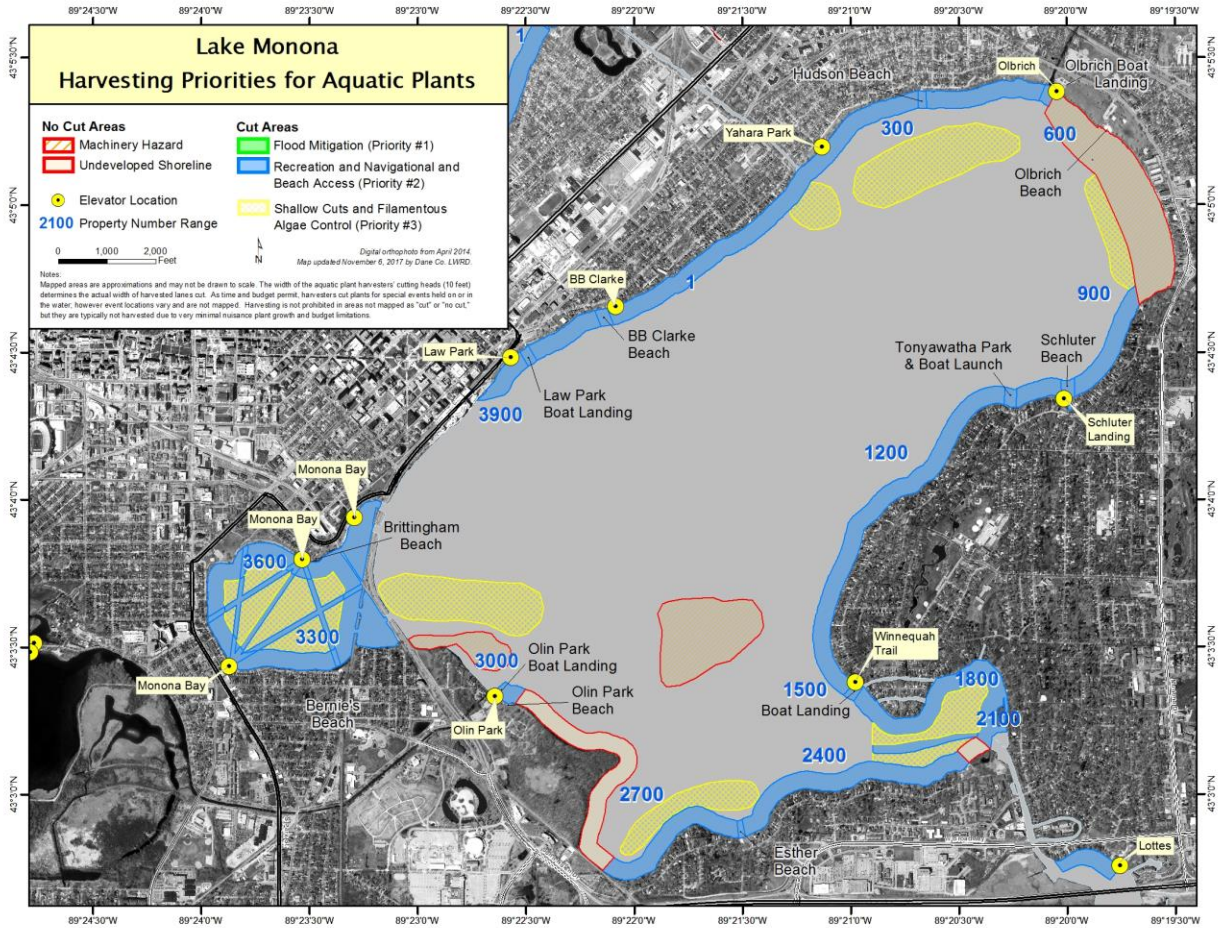
Figure 7. Lake Monona (including Monona Bay) harvesting priorities

Figure 7 is the updated mechanical harvesting priority map for Monona and Monona Bay. Harvesting priorities have not changed from the 2013 plan amendment; however the map has been updated with labels and shoreline features. Additional background on harvesting priorities is found in the Lake Management Operations Manual and posted on the LWRD website (<https://wred-lwrд.сountyofdane.com/Aquatic-Plant-Management/Aquatic-Plant-Harvesting-Program>). Annual training and daily supervision of harvester operators reinforce that plants should be harvested only from these planned areas, unless a variance from the plan has been approved by Wisconsin DNR. Actual effort is dictated based on plant conditions, as evaluated and reported by Dane County’s Plant Scout.
